**SIENA TOWNHOMES POA, INC.  
WAKE FOREST, NC**

**MARCH 07, 2023**

**RESERVE STUDY UPDATE  
with site inspection**

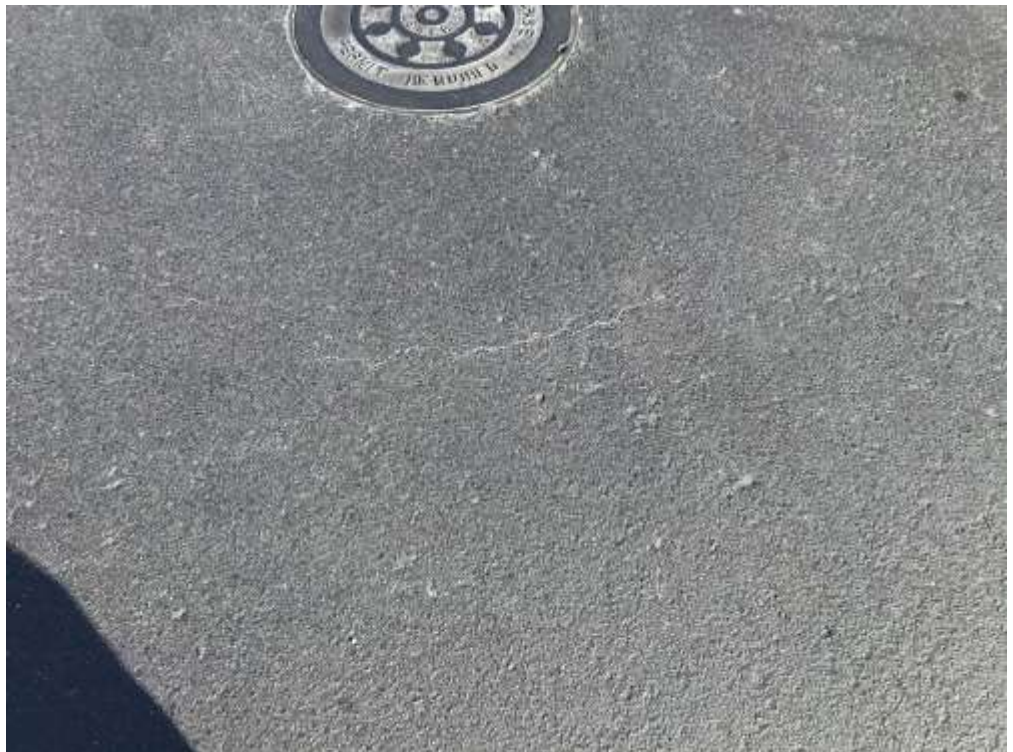
**Photo No.**  
**2**

The streets throughout the community are noted as private streets on recorded plat maps and are assumed to be maintained by the association. The asphalt paving generally appeared to be in good condition. We observed limited areas of minor transverse and longitudinal cracking, as well as areas of patching repairs. The asphalt was reportedly resealed in 2021.

Typical minor cracking

Typically, we recommend crack filling applications and oil resistant sealant to all asphalt paved surfaces on an approximately 5 to 7-year cycle. At this same time, all cracks should be properly filled, patched, and sealed. We have allocated funds for crack fill and seal coat applications of the asphalt pavement on a 5-year cycle beginning in 2027.

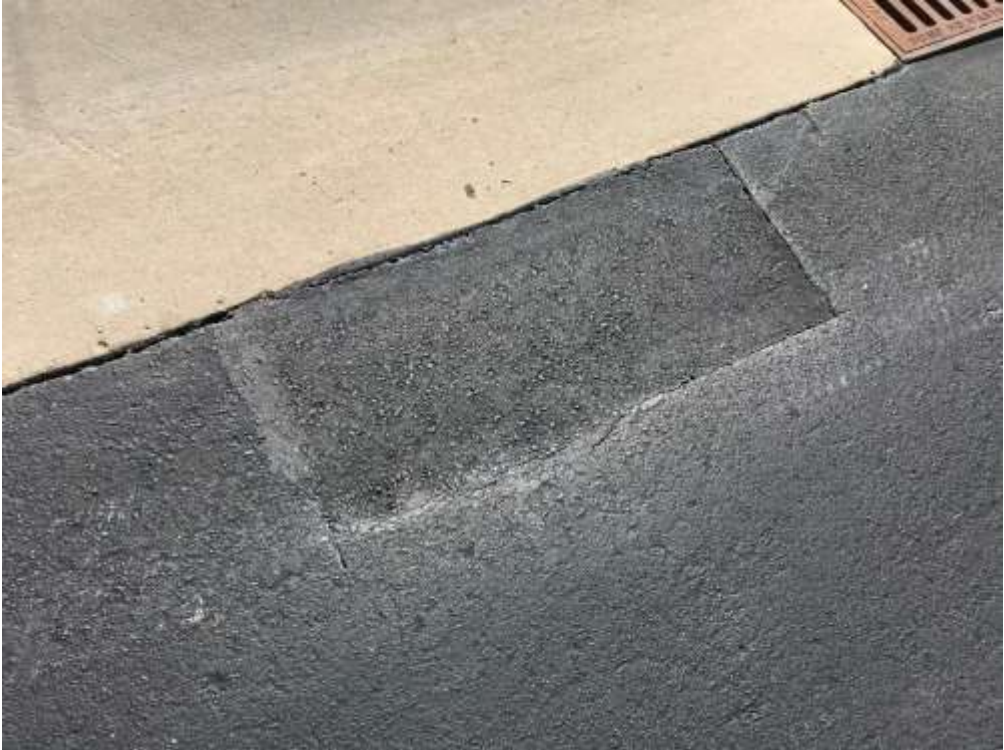
| <b>Photo No.</b><br><b>3</b> | |

| <b>Description</b><br><br>Typical patched area | |

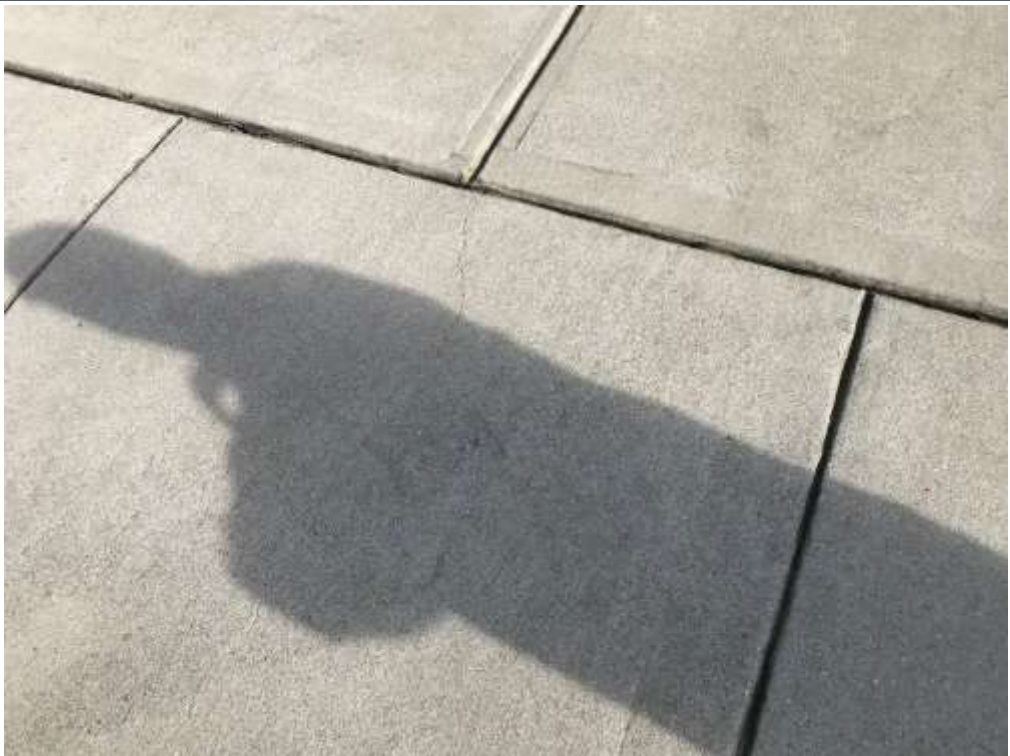
**Photo No.**  
**6**

Typical minor cracking  
in sidewalk

The Association is responsible for the concrete curb and gutter and the concrete sidewalks along the streets in the community. The governing documents appear to note that individual unit owners are responsible for driveways, rear patios and walkways leading to each unit. The concrete flatwork generally appeared to be in good condition and with minor cracking observed. We also noted limited sections of concrete curbing that have been recently replaced. These replacements were reportedly made by the developer. It is likely that as the community ages, cracking and deterioration in concrete surfaces will continue to develop, requiring portions of the concrete flatwork and curbing to be replaced. We have allocated funds to replace approximately 5% of the concrete sidewalks and curb and gutter on an 8-year cycle beginning in 2028.

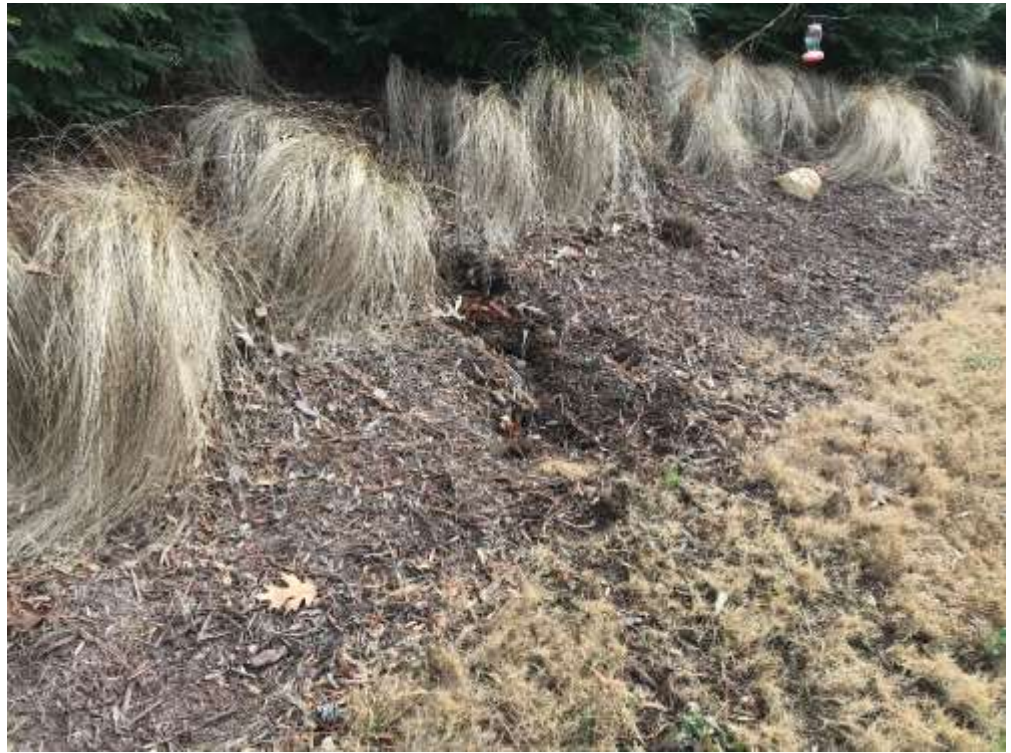
**Photo No.**  
**9**

Site drainage is provided via landscaped swales and catch basins in the paved and landscaped areas. These systems direct water flow to an offsite shared pond. We noted significant erosion, rutting, and saturated soils behind 400-410 Piazza Way. Other, less severe, areas of erosion, ponding water, saturated soils, and poor turf health were noted throughout the community. Most drainage concerns are located along the swales between townhome buildings and within the landscaped areas and swales to the rear of the townhome buildings.

Typical erosion

We have allocated funds for common area drainage improvements on a 5-year cycle beginning in 2023. Due to the amount of drainage concerns noted while on-site, we have allocated a larger amount of funds for drainage improvements in 2023, with a more moderate amount of funds in the years following. Common area drainage repairs will likely include regrading of swales, installation of turf reinforcement or other ground covers along slopes, installation of stone reinforcement along swales and at discharge locations, installation of french drains, and installation of underground piping systems with catch basins. Note that some common area drainage improvements may be difficult due to utilities and may require hand digging. The association may consider hiring an engineer to evaluate areas of concern to determine the most efficient solutions prior to completing drainage improvement projects.

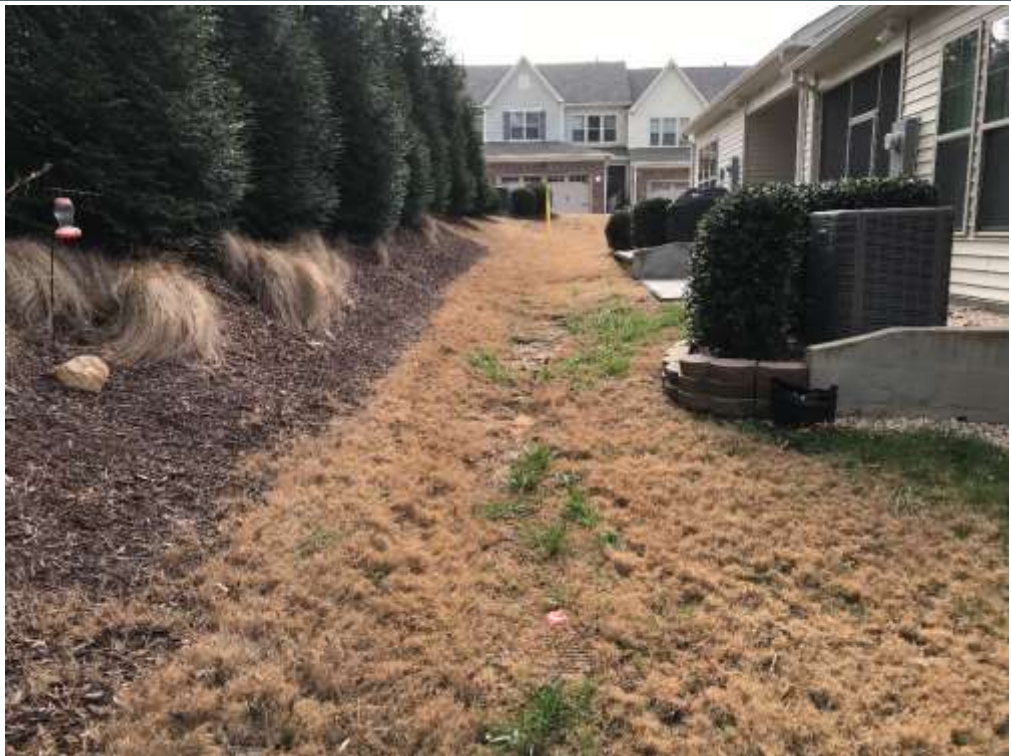
**Photo No.**  
**10**

Typical saturated soils  
and erosion

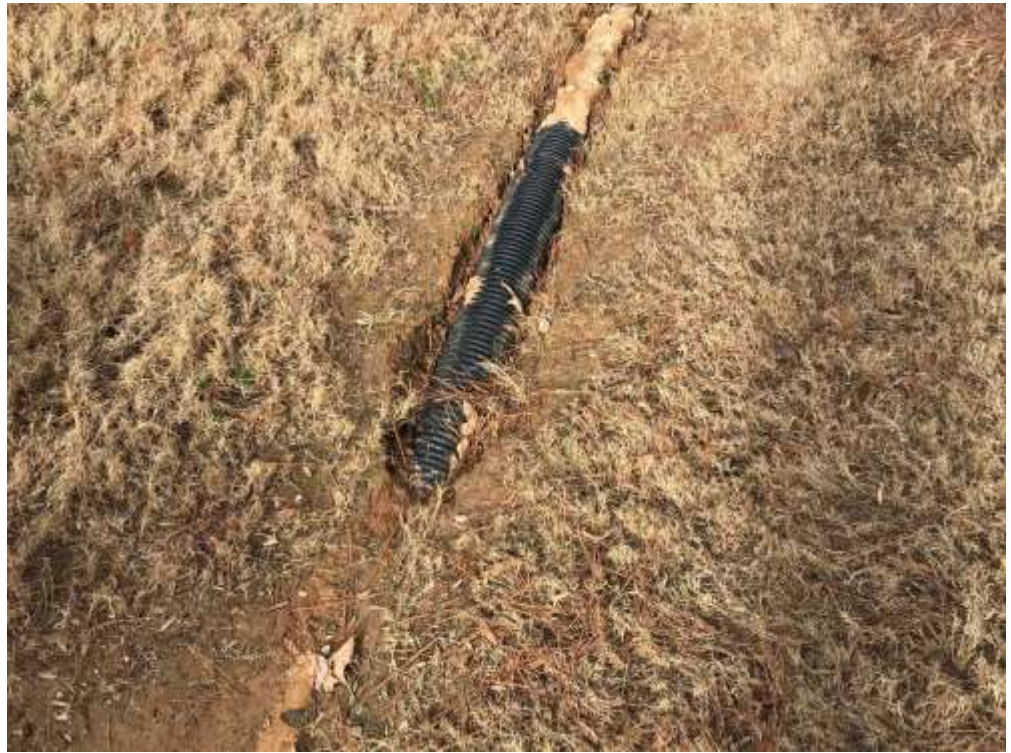
**Photo No.**  
**11**

Typical erosion

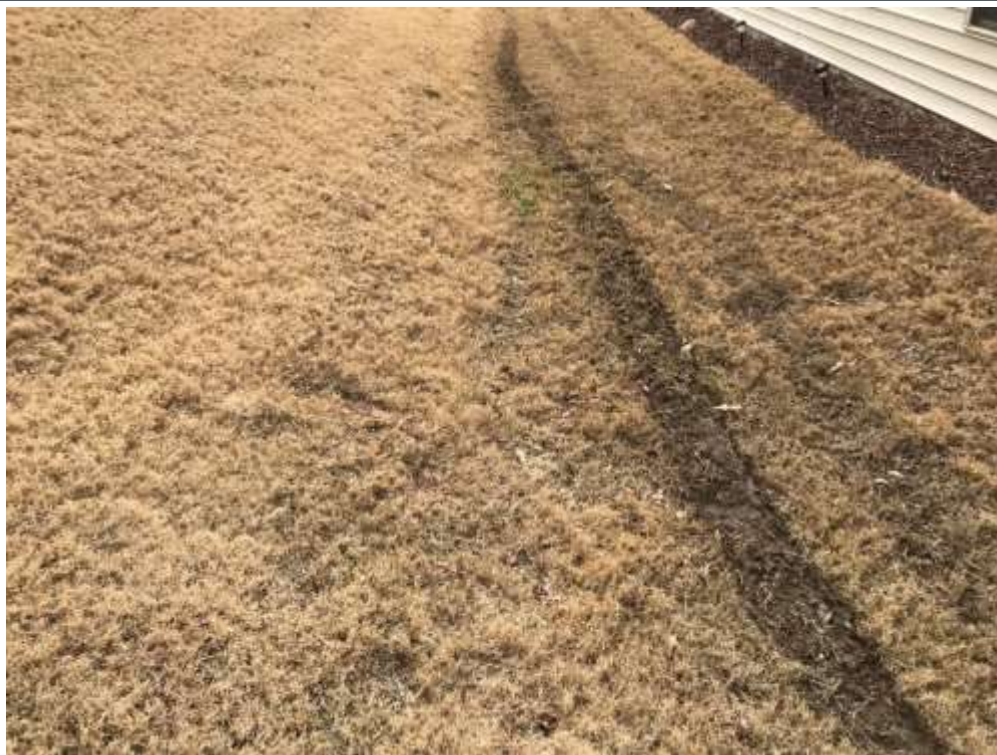
**Photo No.**  
**13**

Multiple areas of neutral grade were noted along the rear perimeter of the townhome buildings that reportedly leads to standing water on rear patios. The townhome association has reportedly completed recent common area drainage improvements throughout the community which have included extending downspout leaders beneath grade away from the building perimeters, regrading of swales, and installation of underground pipe systems and catch basins. Note that the association is only responsible for drainage systems in the common areas and not on individually owned lots.

Typical area with  
saturated soils and poor  
turf health

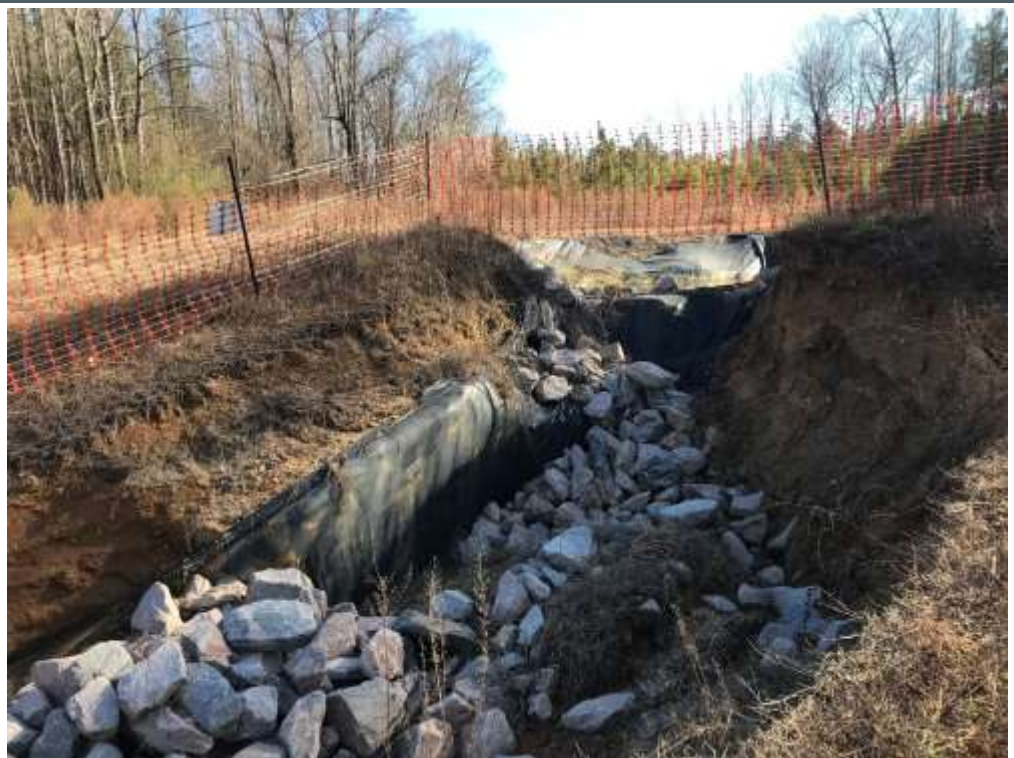
**Photo No.**  
**16**

The off-site stormwater pond is understood to be a shared component with adjoining properties. The pond generally appeared to be incomplete and it is our understanding work to the stormwater pond is planned to be enlarged in the near term for the new Wake Med facilities. We have assumed the pond will be completed and in adequate condition in the near term and that the cost of this work will not be the responsibility of the association. We have allocated funds for major pond improvements and silt removal on a 25-year cycle beginning in 2039. This larger repair work is expected to include items such as: dredging accumulated sediment, significant erosion repair, repair or replacement of erosion control geofabric, and replacing riprap. The HOA should ensure that the pond conforms to all applicable regulations at all times.

Significant erosion at  
inlet

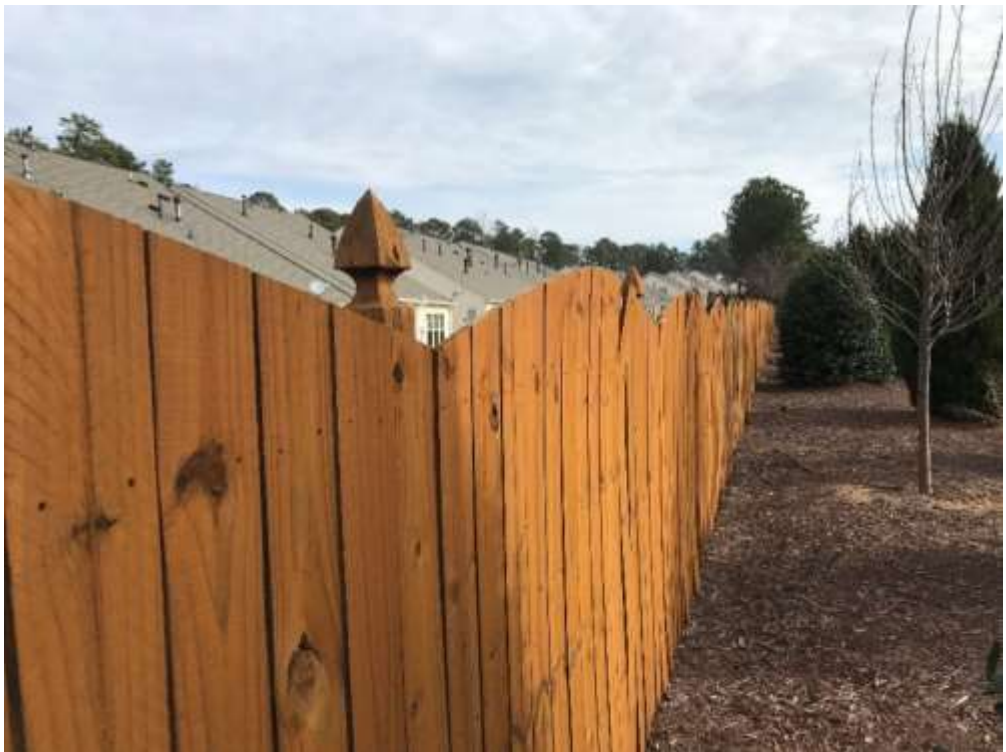
**Photo No.  
22**

Six-foot-tall wood fencing is located around a significant portion of the perimeter of the property and appeared to be in fair condition. We observed a number of fence boards that were cracked or warped. We also noted a section of fence along the southern portion of the property that was reportedly repaired in 2022. Staining/sealing has been completed on the sections of wooden fencing along the northern border of the community with the fencing along the western and southern borders are to be stained and sealed in 2023. We have allocated funds for future stain/seal applications on 5-year cycles beginning in 2023. Due to the amount of cracking and warping noted in the fence slats while on site, we have allocated funds to replace the wood fencing on a 15-year cycle beginning in 2034.

Typical warped fence  
slat

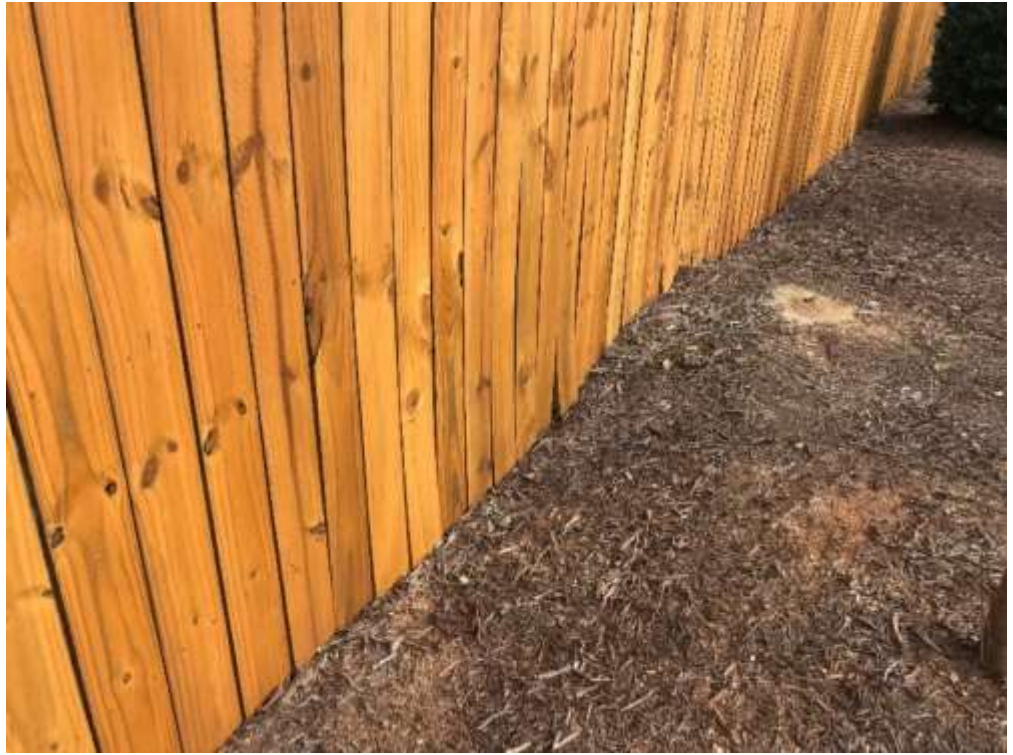
**Photo No.**  
**23**

Typical warped fence  
slat

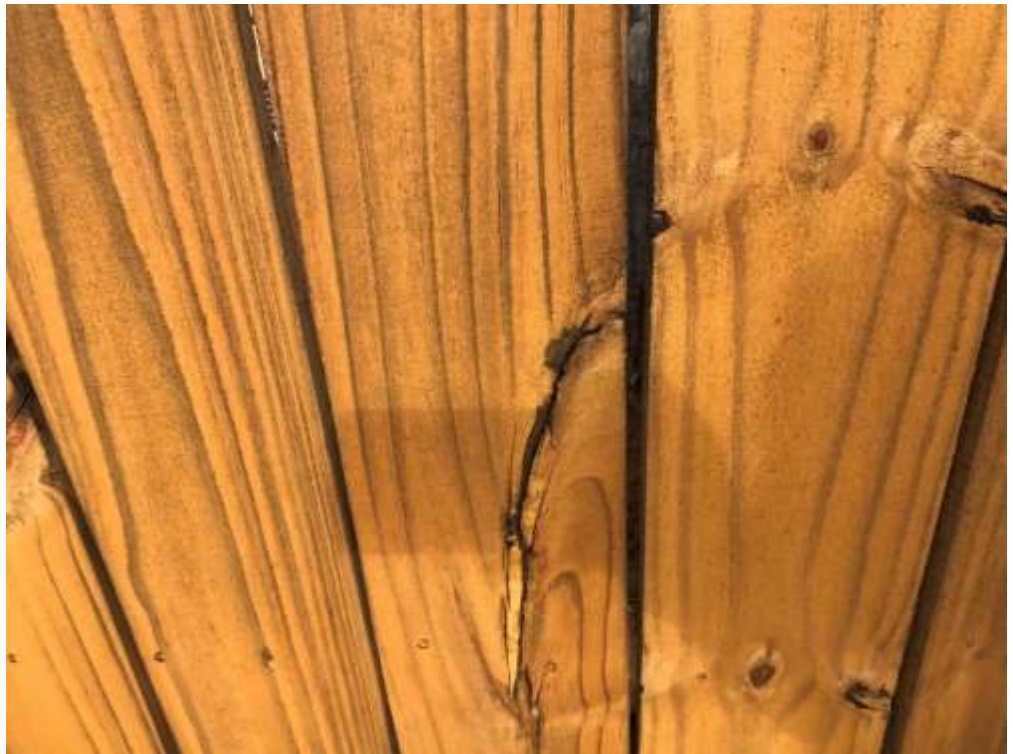
**Photo No.**  
**24**

Typical cracked fence  
slat

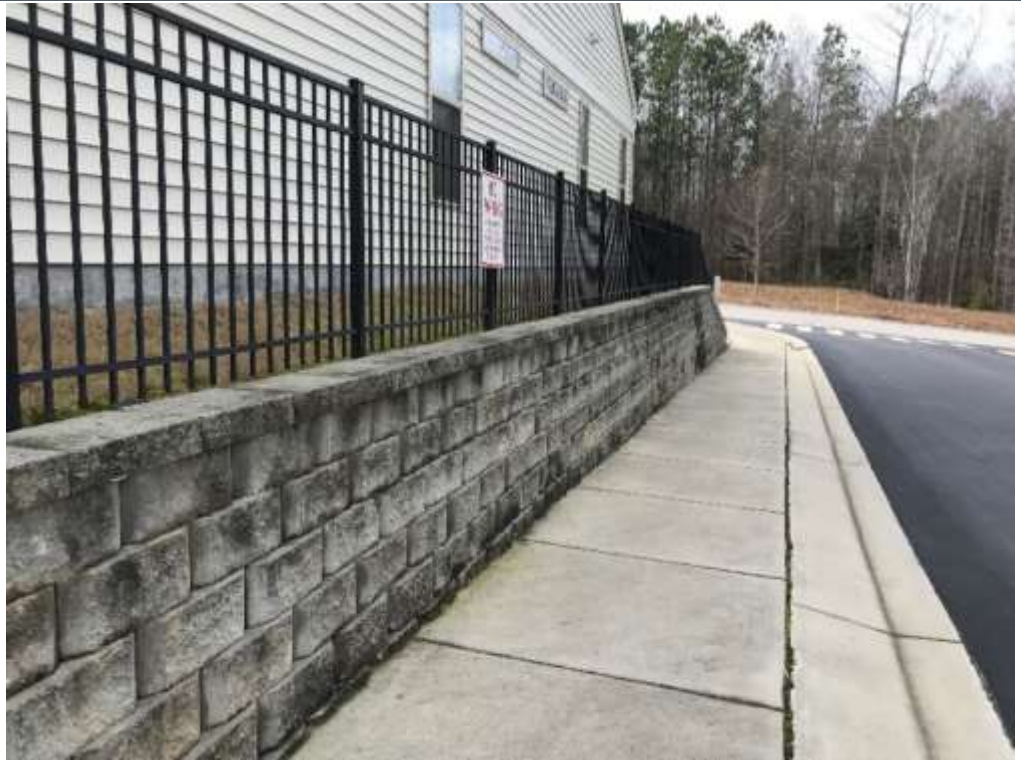
**Photo No.**  
**27**

Several moderate to large segmental block geo-grid reinforced retaining wall systems up to approximately 10-feet in height are installed around the community. It is our understanding that issues regarding the drainage behind the retaining walls has become a concern. During rain events, the wall drains reportedly do not discharge water. Additionally, it is our understanding that water leaks through or discharges over top of the walls. We did not observe any signs of distress such as leaning walls or displaced blocks while on site. However, we were unable to visually inspect the wall along the northern border of the property due to dense vegetation.

Typical segmental block retaining wall and aluminum fencing

**We recommend the association complete a borescope investigation of the retaining wall drains to determine if the drains have become blocked or have crushed. Additionally, to help reduce the amount of stormwater collection behind the walls, downspout leaders may be redirected away from the retaining walls to discharge into other landscaped or paved areas. Finally, we recommend removing the dense vegetation along the wall at the northern end of the property so that wall may be routinely inspected for signs of distress.**
